Colonial_6Mile 144 North Panel 1

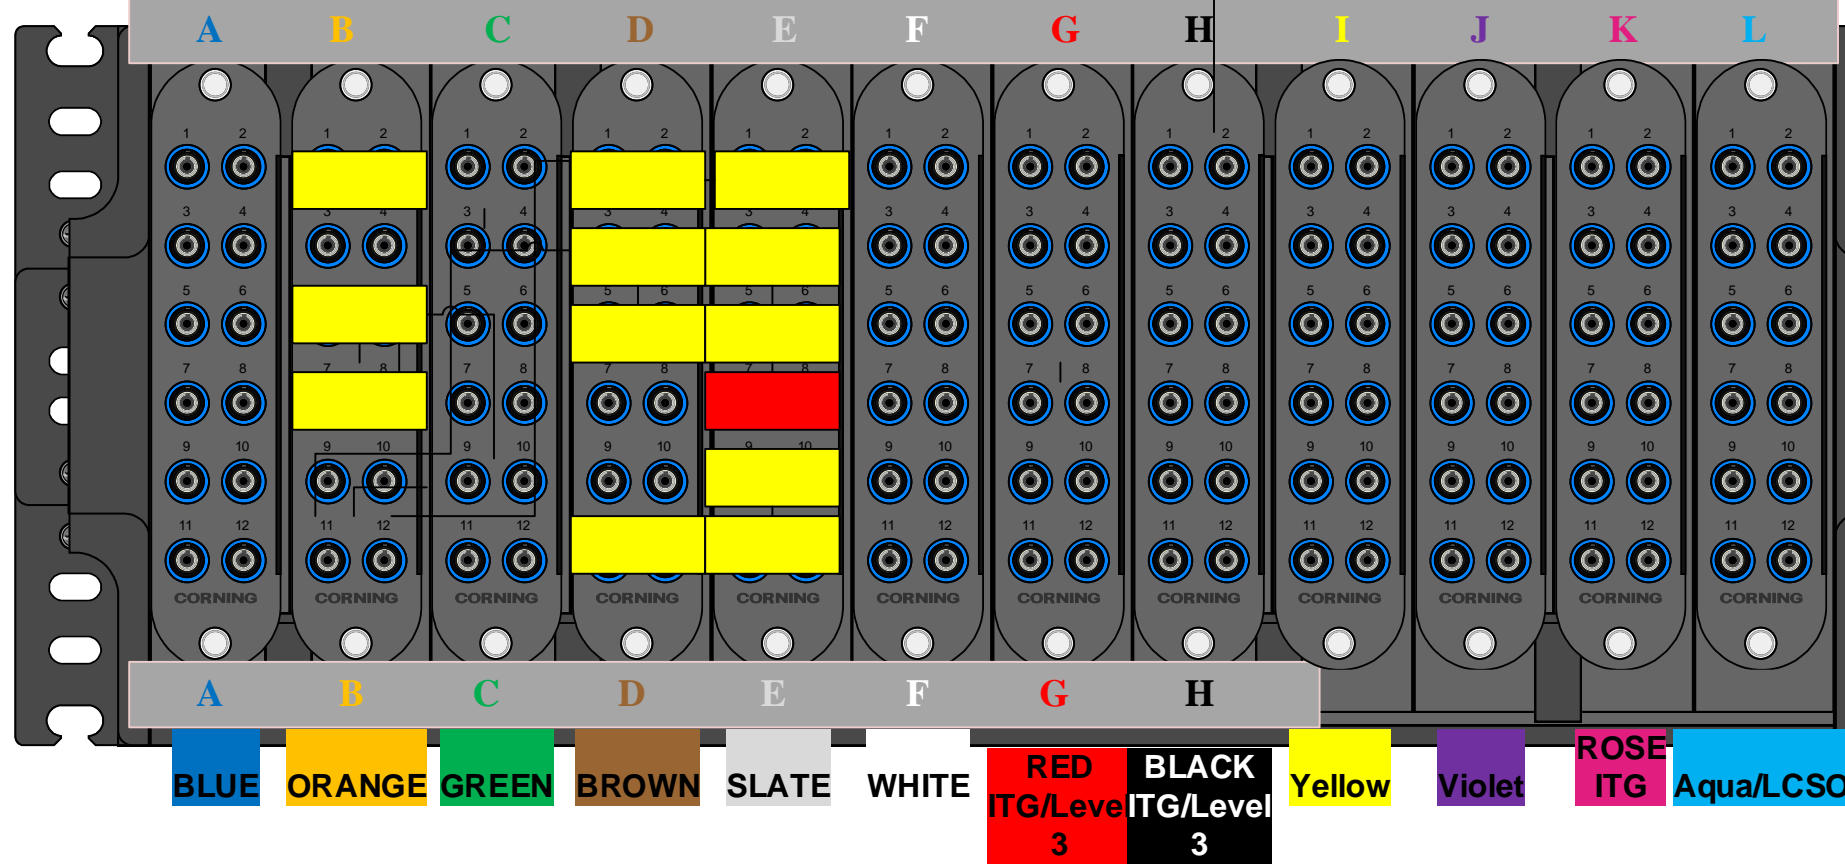
- B 1-2 to Port 14 on Cisco IE 5000
- B 5-6 to Port 17 on Cisco IE 5000
- B 7-8 to Port 23 on Cisco IE 5000
- D 1-2 to D 1-2 Panel 3 (96 West)
- D 3-4 to Panel 3 A 9-10
- D 5-6 to Panel 2 C 5-6
- D 11-12 to Port 15 Cisco (Evans/Edison)
- E 1-2 to Panel 3 C 1-2
- E 3-4 to Panel 3 D 3-4
- E 5-6 to Port 25 Cisco IE 5000 10 gig
- E 7-8 to redundant 1g (not hooked up)
- E 9-10 to Panel 3 H 9-10
- E 11-12 to Panel 3 H 11-12

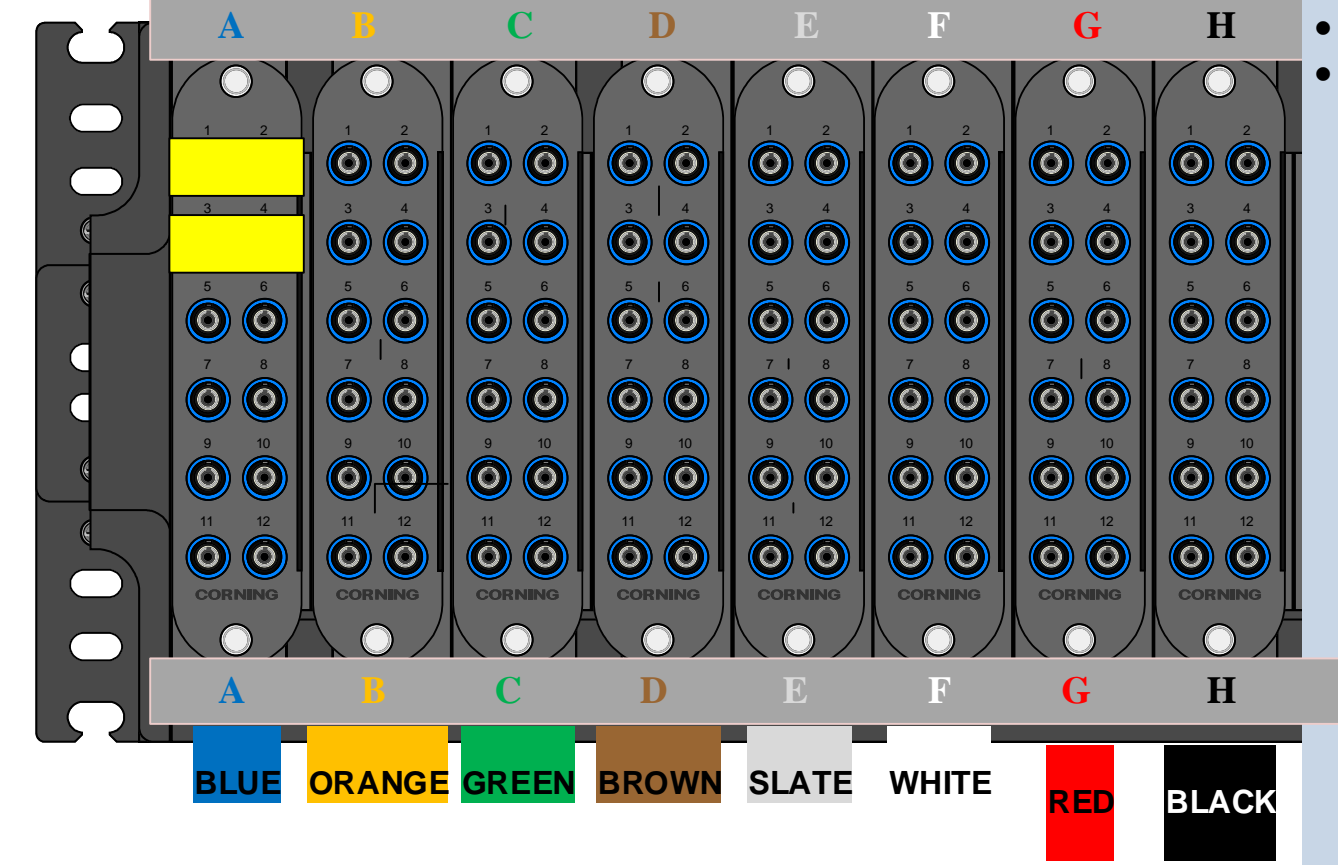
Colonial_6Mile 96 East Panel 4

- A 1-2 to Port 22 on Cisco IE 5000
- A 3-4 to Port 13 on Cisco IE 5000

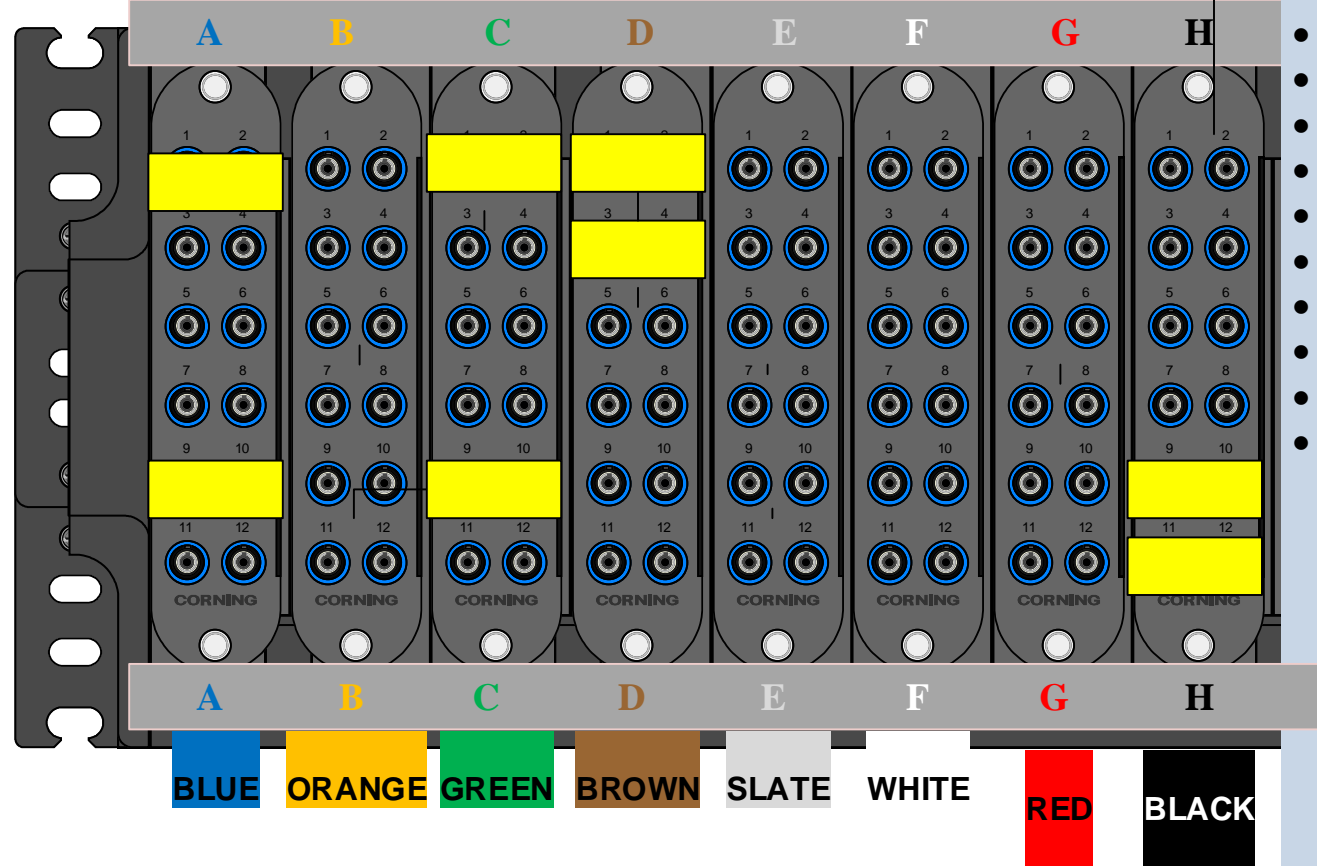
Colonial_6Mile 96 West Panel 3

- A 1-2 to Port 21 on Cisco IE 5000
- A 9-10 to Panel 1 D 3-4
- C 1-2 to Panel 1 E 1-2
- C 9-10 goes no where
- D 1-2 to Panel 1 C 1-2
- D 3-4 to Panel 1 E 3-4
- H 9-10 to Panel 1 E 9-10
- H 11-12 to Panel 1 E 11-12
- Fibers 7,8,9,11 are bad from Plantation-Colonial to McGregor Baptist-Colonial

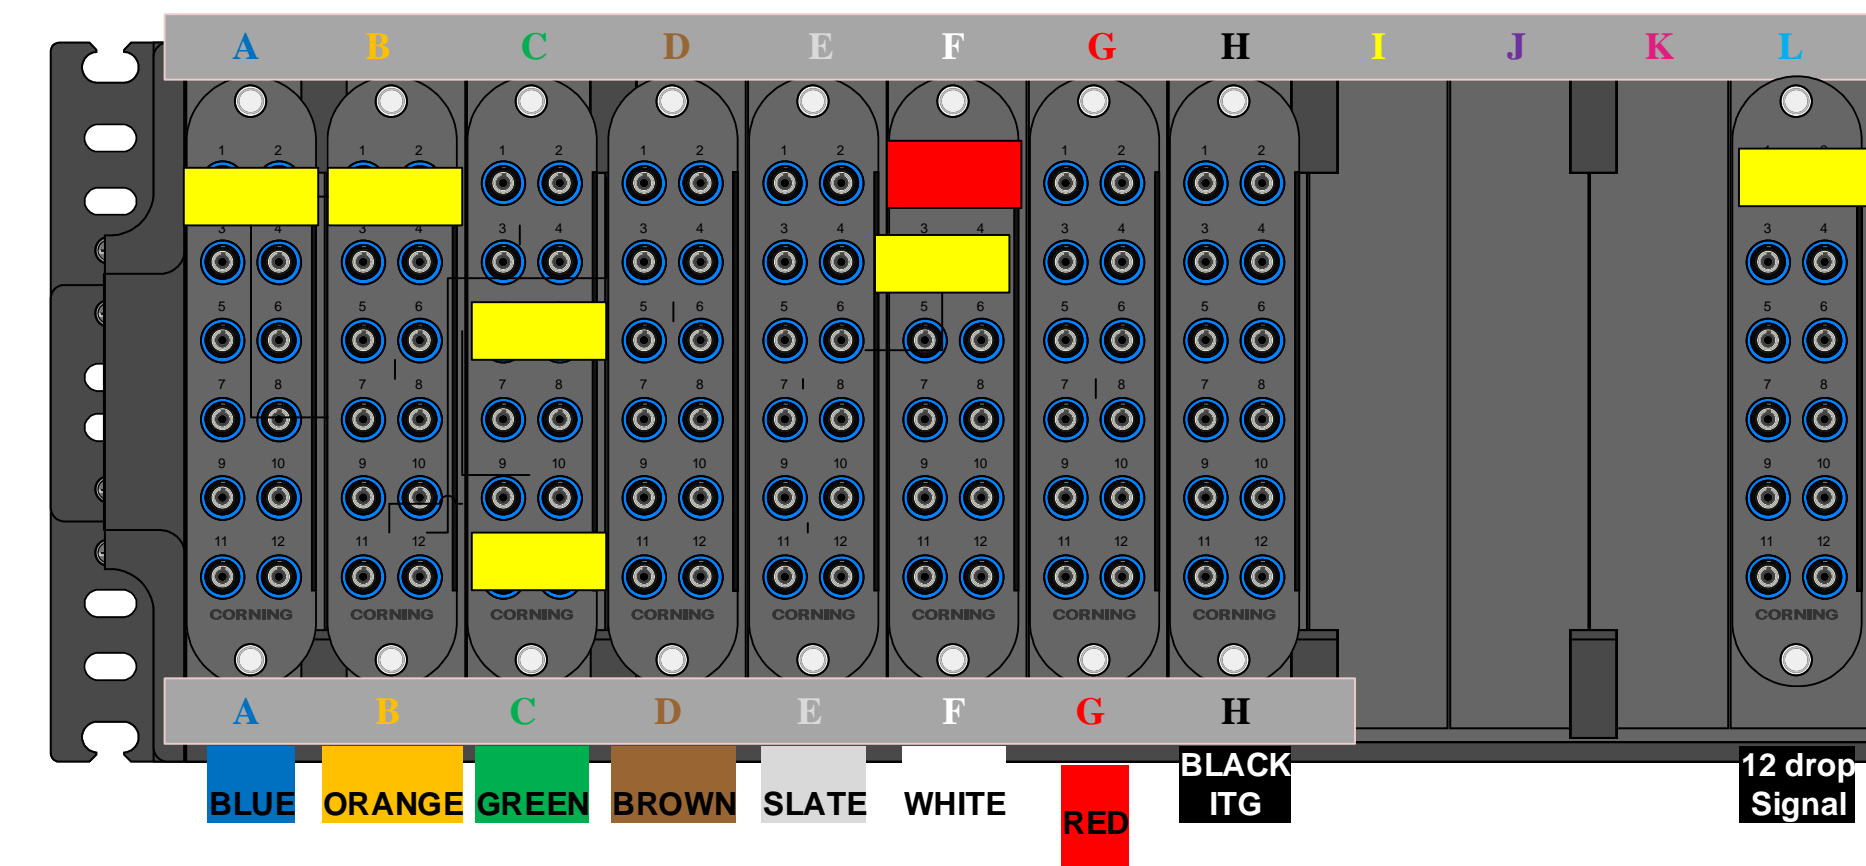
Colonial_6Mile 96 South Panel 2

- A 1-2 to Port 24 on Cisco IE 5000
- B 1-2 to Port 18 on Cisco IE 5000
- C 5-6 to Panel 1 D 5-6
- C 11-12 to Port 19 on Cisco IE 5000
- F 1-2 Unreliable probably pinched south of Dani Dr
- F 3-4 to Port 20 on Cisco IE 5000
- L 1-2 to Port 16 on Cisco IE 5000
- Black Buffer ITG
